Mooney Mite Series M-13
Service Bulletin No. 14

Purpose:

The purpose of this Bulletin is to provide information on the allowable free play of the tail surfaces of the subject model aircraft and such other information concerning bushing wear, etc., as is necessary to correct an unsatisfactory condition found on several airplanes, which if allowed to continue, could perhaps result in a dangerous situation.

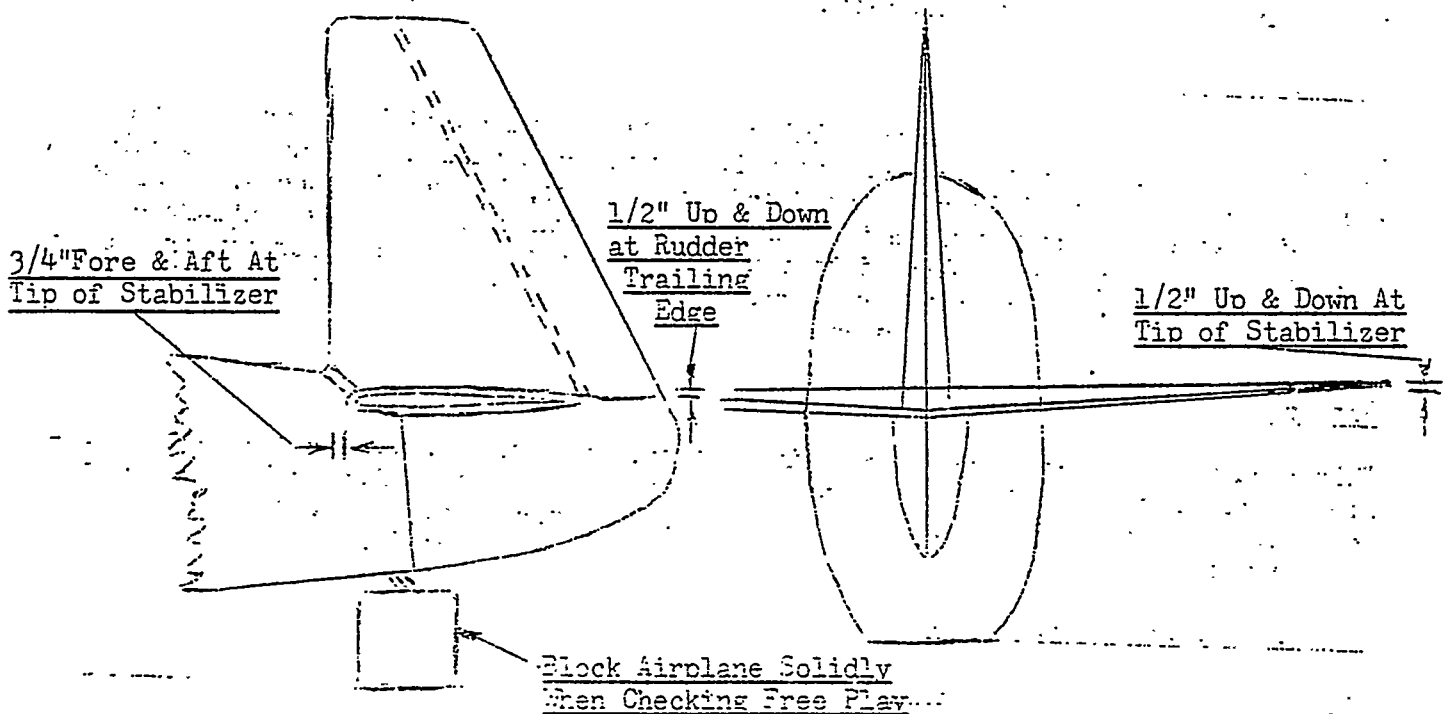
The following sketch illustrates the maximum allowable free play at the specified points.

When checking stabilizer tip free play, either fore and aft or up and down, measure free play on the opposite tip from where the stabilizer is moved by application of hand pressure. This eliminates errors in measuring due to bending deflections of the stabilizer itself.

First inspect all tail surface joints and attachment bolts for tightness. All Bolts Should Be Tight, since bushings are intended to take the wear. If any bolt is loose, inspect for wear, and replace if necessary, using washers if required, and make sure all bolts are tight. Then block tail of airplane solidly and check free play as indicated by sketch.

If any or all of free play limits are exceeded, find which joint or joints seem to have most play and replace bushings until free play is within limits. In this connection, the up and down free play at the rudder root trailing edge is also affected by wear in the adjustable stabilizer trim system, particularly for the Model M-18L, where the 886 screwjack, located at the rear fuselage bulkhead, may exhibit excessive end play. In this case, either replace or rework the screwjack to eliminate the excessive end play.
