MOONEY AIRCRAFT, INC.  
M-18 SERVICE LETTER NO. 16  
(This Service Letter is F. A. A. Approved)

DATE: October 16, 1959  
SUBJECT: General Inspection and Rework  
MODELS AFFECTED: All M-18 Series Aircraft  
TIME OF COMPLIANCE: Within the next 10 flight hours but not later than 11-15-59

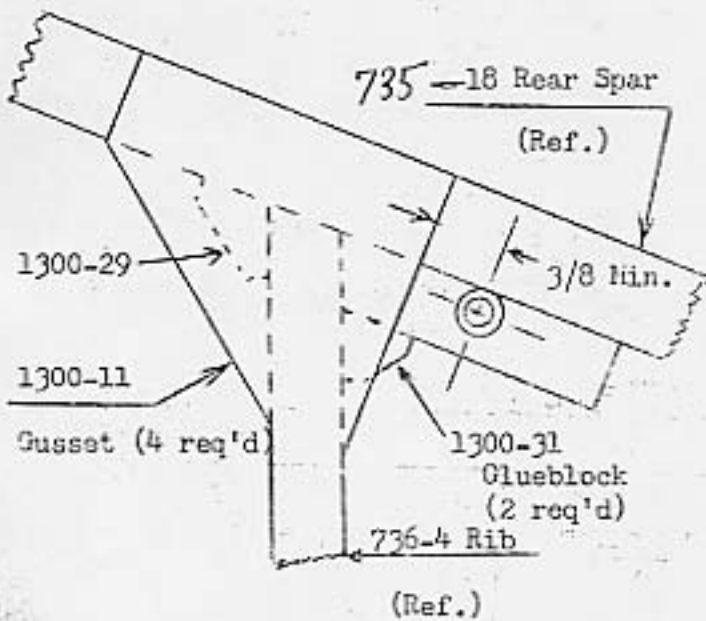
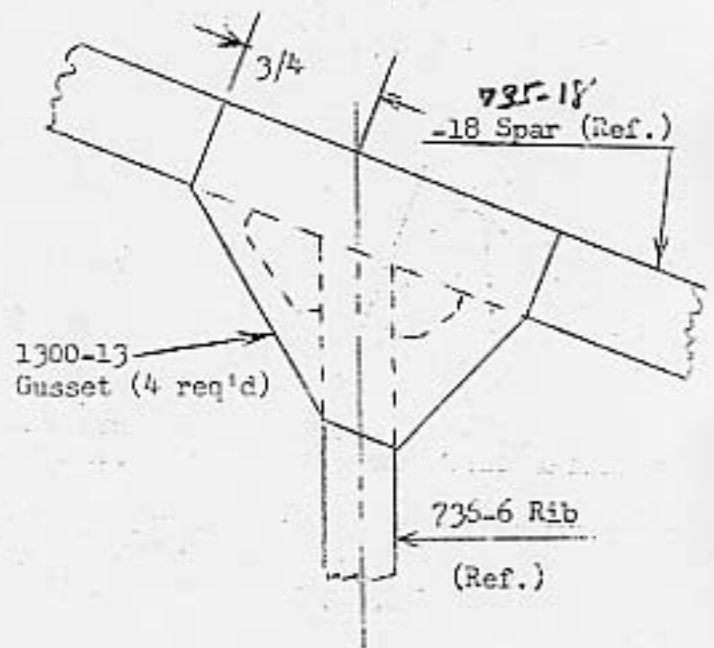
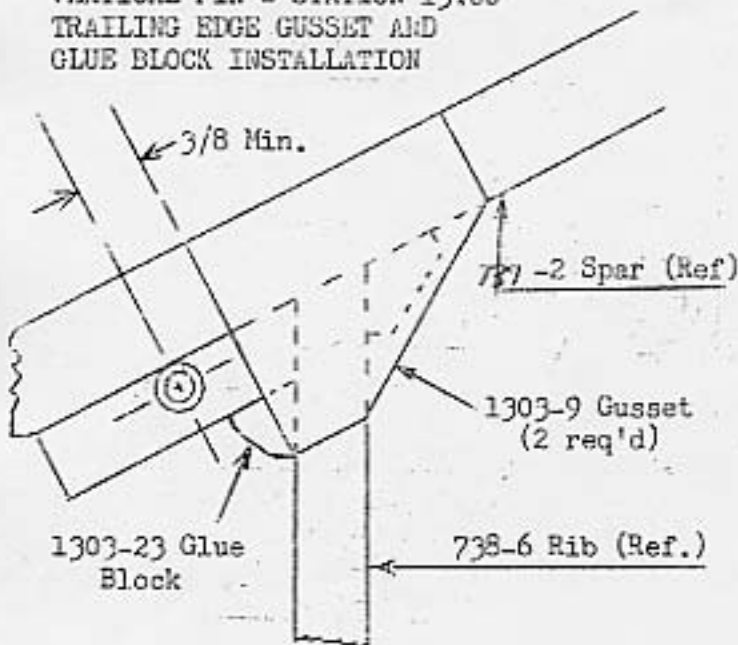
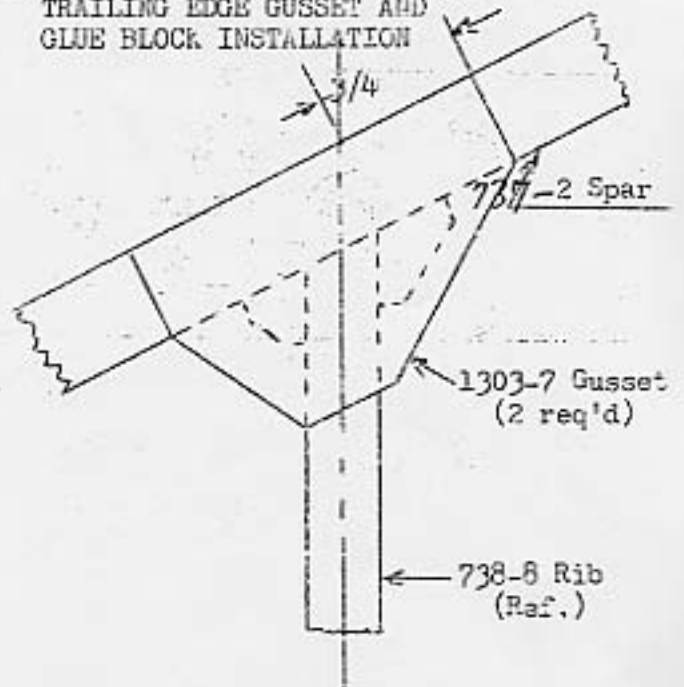
Figure 2

Several cases of wood and glue joint deterioration have been reported on M-18 aircraft. Instances have been reported of cracks in the horizontal stabilizer spar and loosening of the attach blocks on this spar. It is therefore recommended that (1) care be exercised in future inspection and maintenance and, (2) that care be exercised during ground handling of the aircraft so that the horizontal stabilizer will not be damaged. In view of the findings of an investigation of a recent accident involving an M-18, it is mandatory that the following inspection and rework be accomplished.

4. At center section of horizontal stabilizer spar inspect glue joint between attach blocks and spar for deterioration and inspect spar and blocks for cracks. Inspect fin spar for cracks at attach bolt bushings.

5. Any defective wood parts shall be replaced or repaired in accordance with Civil Aeronautics Manual 18 and/or manufacturers recommendations. When it is determined that the fin and horizontal stabilizer are in satisfactory condition, the rework shown in-Figures 1 and 2 shall be accomplished. The glue used shall be a urea-formaldehyde type such as Weldwood or Cascamite. Parts for the required rework are available at no cost. Order Kit SL18-16 from the Spare Parts Department of Mooney Aircraft, Inc.

STABILIZER - STATION 16.375  
TRAILING EDGE GUSSET AND GLUE  
BLOCK INSTALLATION

STABILIZER - STATION 32.75  
TRAILING EDGE GUSSET AND GLUE  
BLOCK INSTALLATION

VERTICAL FIN - STATION 13.00  
TRAILING EDGE GUSSET AND  
GLUE BLOCK INSTALLATION

VERTICAL FIN - STATION 25.25  
TRAILING EDGE GUSSET AND  
GLUE BLOCK INSTALLATION
