MOONEY AIRCRAFT, INC.

M-18 SERVICE LETTER NO.17

DATE: OCTOBER 24, 1959  
SUBJECT: REAR BULKHEAD REINFORCEMENT  
MODELS AFFECTED: NOTED  
TIME OF COMPLIANCE: IN CONJUNCTION WITH MOONEY M-18 SERVICE LETTER NO. 16

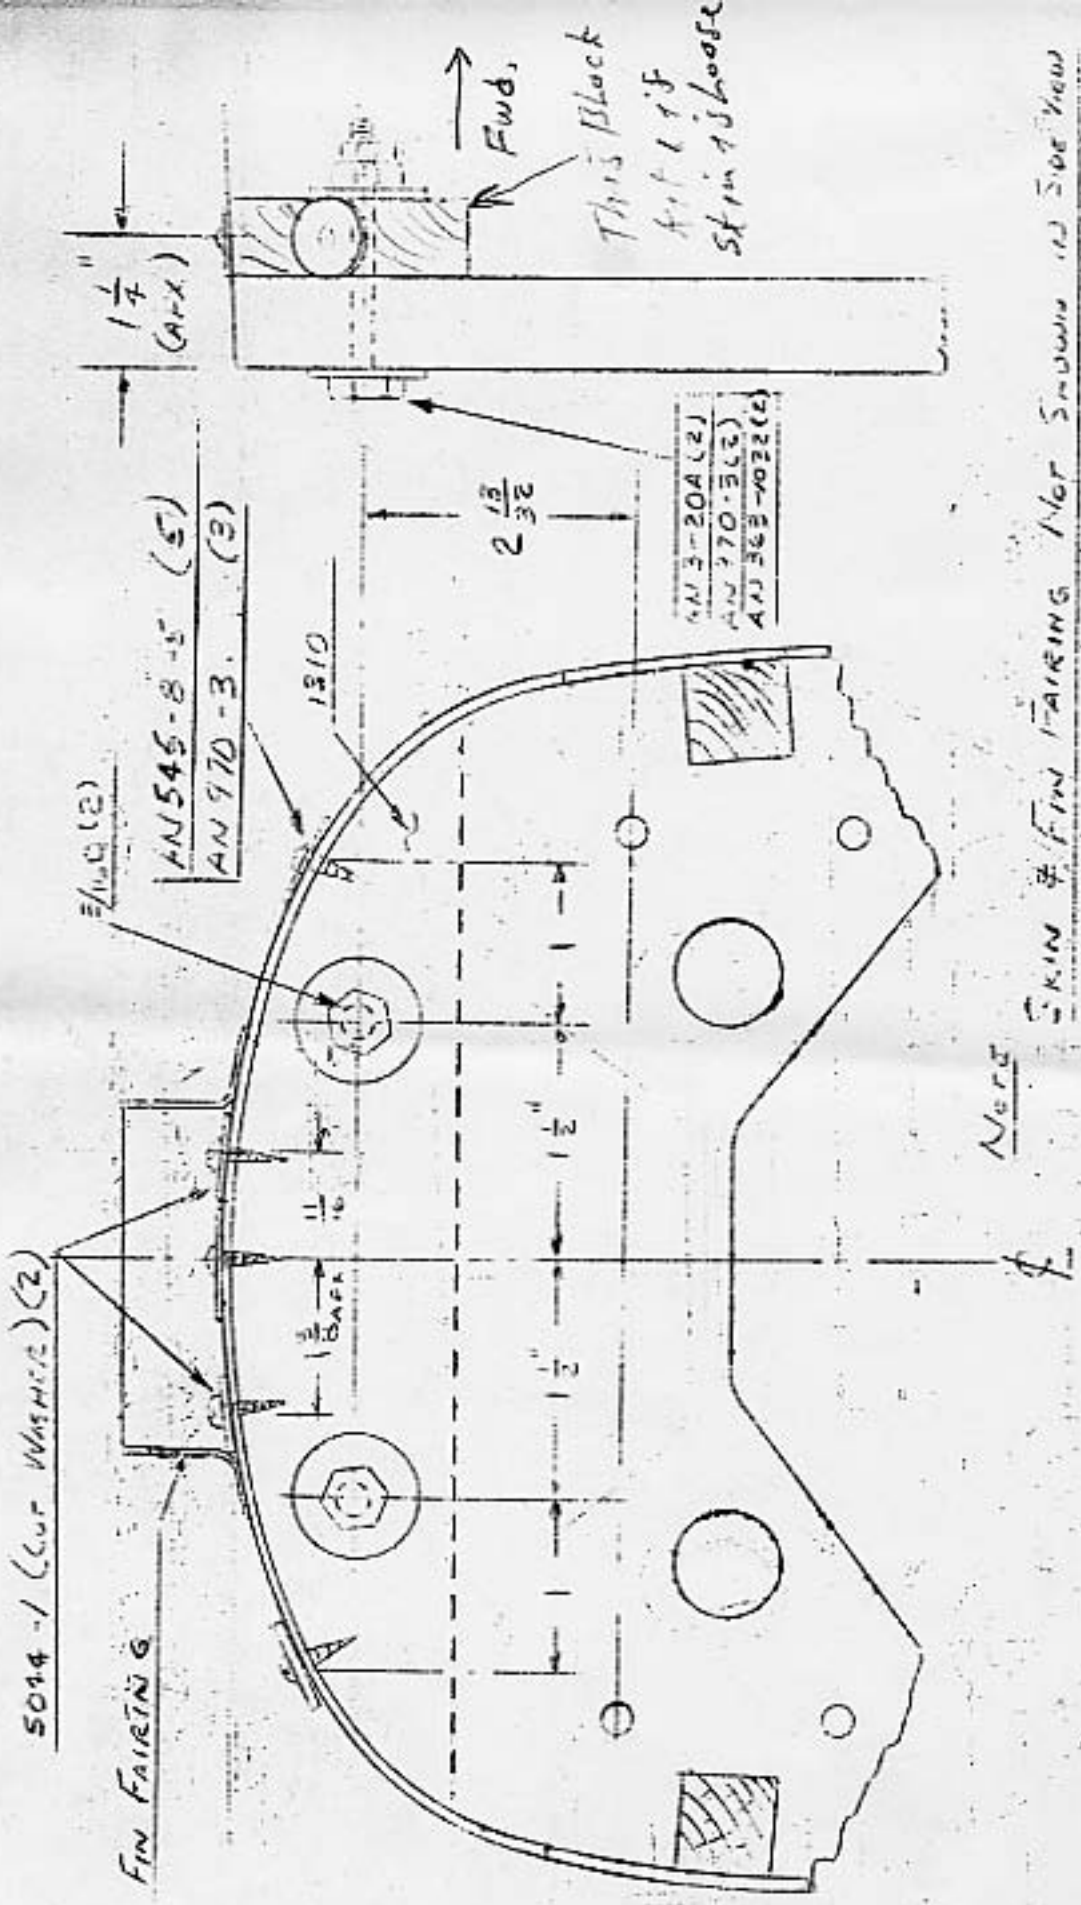
NOTE SKIN & FIN FAIRING NOT SHOWN IN SIDE VIEW  
FIG. 1

- 1) Loose glue joint between bulkhead and tail cone skin at top of bulkhead.
- 2) Separation of plywood web and spruce core.
- 3) Cracks of plywood web and/or spruce core in the area of the empennage attachment brackets.

1. All airplanes having the defect described in Item 1 of the Introduction are to be repaired in accordance with Figure 1 or Figure 2 depending on the type of elevator control system.
2. Order Rework Kit SL 18-17-1.

NOTE. THIS DRAWING IS FOR M-18 MODELS EQUIPPED WITH THE PUSH-PULL ELEVATOR CONTROL SYSTEM.
