(This Service Bulletin Supersedes Service Bulletin M20-170)

INSTRUCTIONS TO PREVENT VIOLATIONS
OF STANDARD AIRCRAFT PRACTICES FOR
MAINTAINING WOOD STRUCTURES

M20 and M20A, all serial numbers

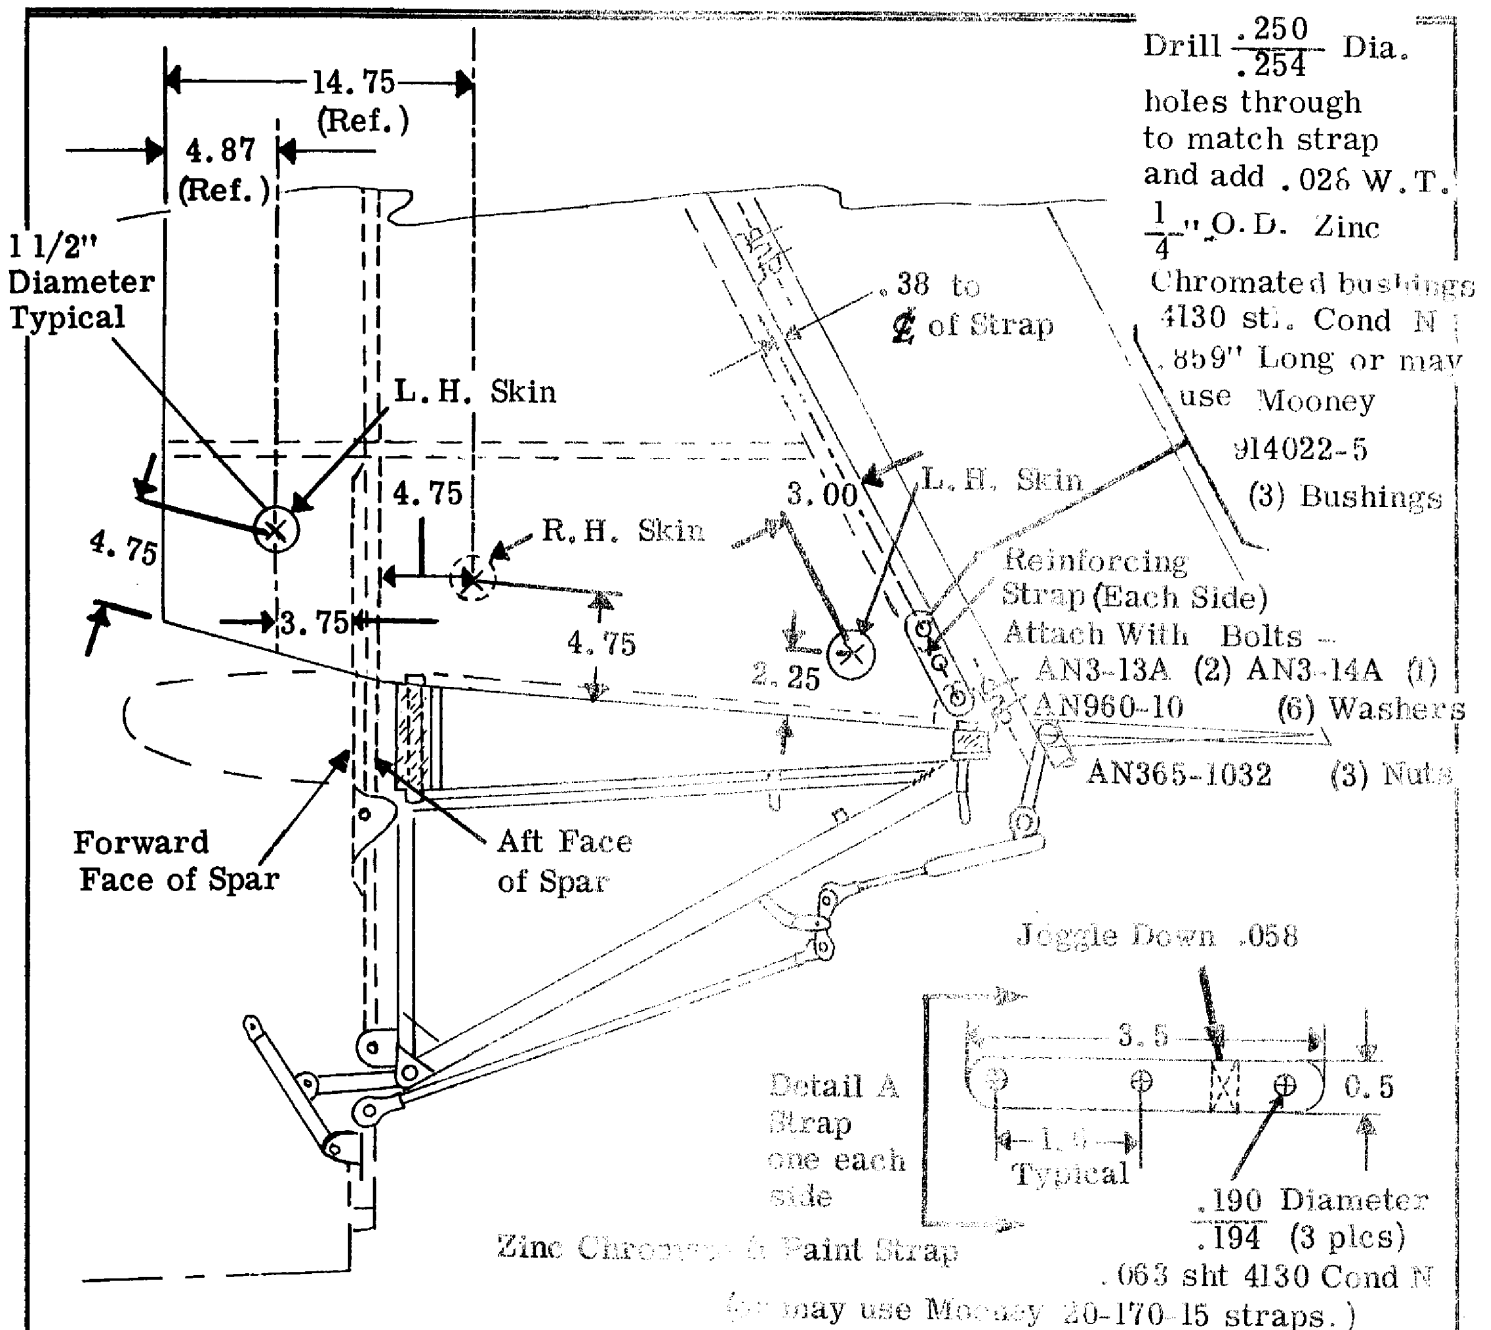
FIG.1 EMPENNAGE INSTALLATION

- A. Remove all the fabric from the horizontal and the vertical stabilizers and carefully inspect all the wood skin for condition, and the wood skin attach areas for separation of glue joints (reference Figures 2 and 3). Gently flexing adjacent parts and tapping joints with a small plastic mallet or hammer while listening for variations or changes in the sounds emitted are recognized aids during visual inspection. Flex and closely inspect the glue joints between the wood skin and main spar at bottom fin rib. **IF THE WOOD SKIN IS CRACKED, DISCOLORED, DETERIORATED, OR NOT ATTACHED TO THE FIN MAIN SPAR AT THE BOTTOM RIB, REMOVE THE SKIN IN THIS AREA AND CAREFULLY INSPECT THE SPAR FOR CRACKS AND DETERIORATION. THE WOOD SKIN SHOULD BE REMOVED IN THIS AREA REGARDLESS OF CONDITION UNLESS THE INSPECTOR CAN ASSURE HIMSELF THAT THE SPAR IS NOT DAMAGED. THE FIN MAIN SPAR SHOULD ALSO BE CAREFULLY INSPECTED BELOW THE BOT-**

- B. Add inspection access holes per instructions noted on Figures 1 and 2.
- C. Install two straps on bottom aft area of the fin per instructions noted on Figure 1 (Detail A).

Add access holes 1.5 inches diameter (smooth all edges) close holes using 5.5 inch diameter doped patches. Install reinforcing straps (P/N 20-170-15) or its equivalent picking up top cluster fitting attach bolt. (See Detail A use bolt sizes noted above) Install the bushings (P/N 914022-5) by first saturating the holes with spar varnish.

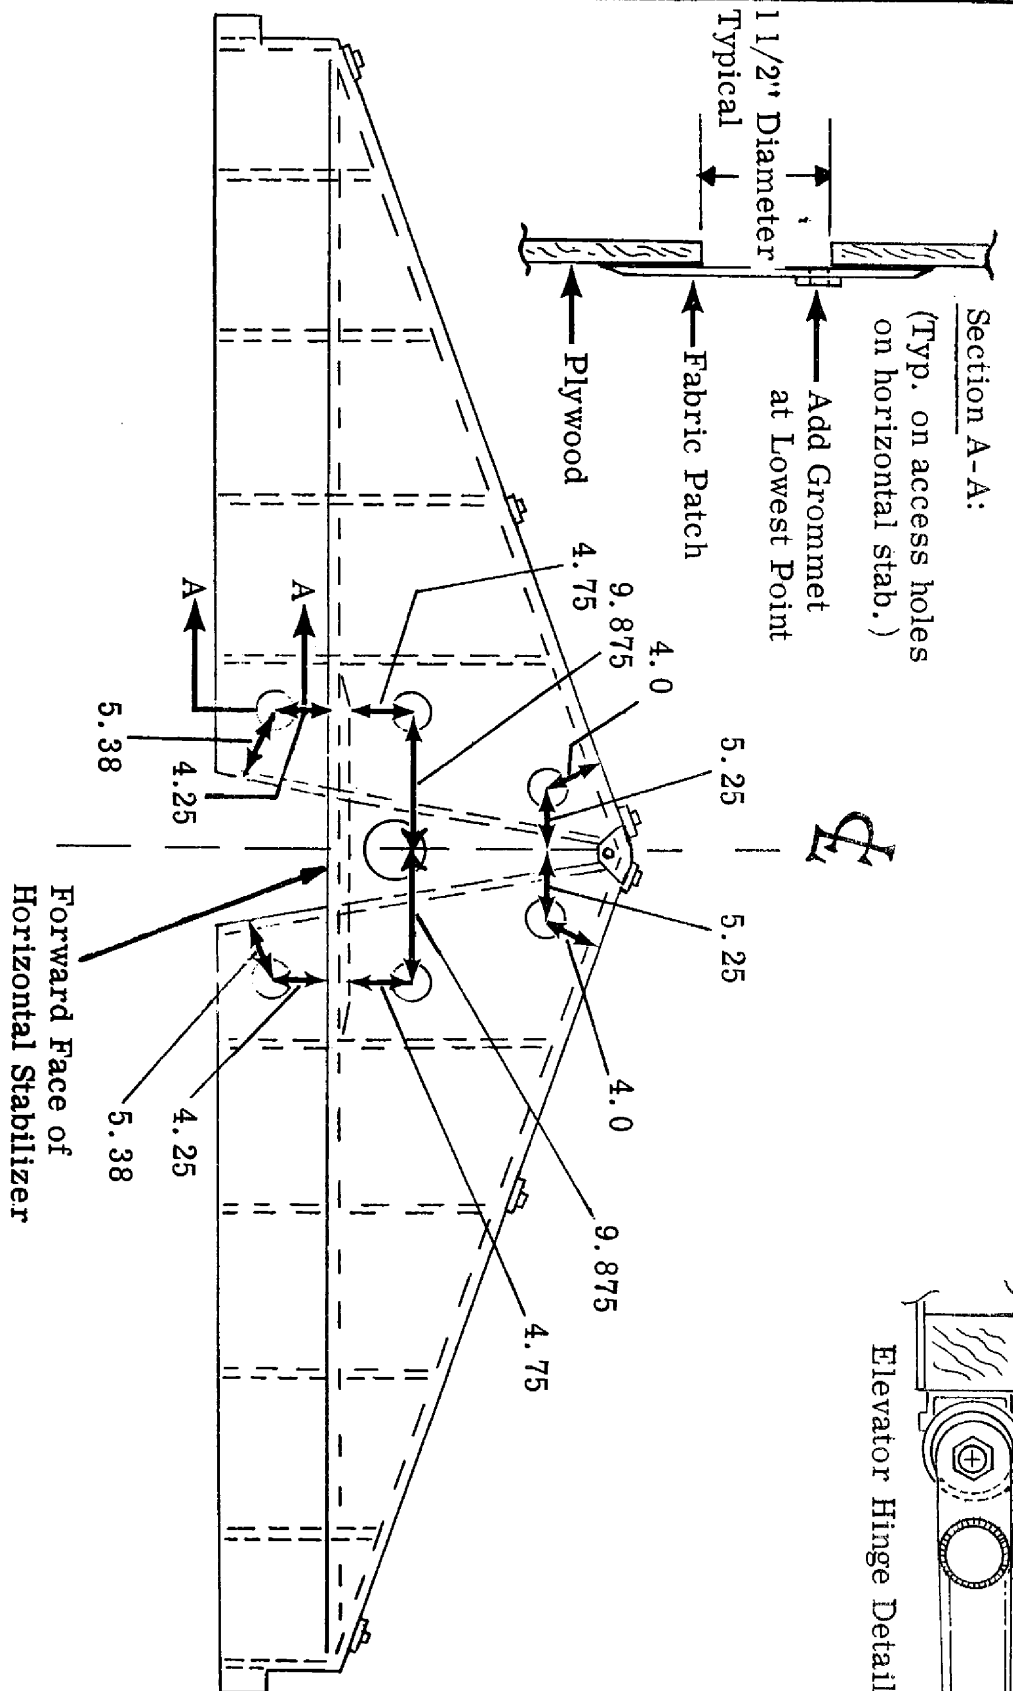
FIG. 2 STABILIZER BOTTOM VIEW

1. Carefully inspect all the skin attach areas (reference Figures 2 and 3) for separation of glue joints by gently flexing adjacent parts or by tapping the joints with a small plastic mallet or hammer while listening for variations or changes in the sounds emitted. Rework all separated glue joints before further flight.

Add access holes 1.5 inches diameter in bottom skins as shown. (smooth all edges.) Close holes using 5.5 inch Dia. doped patches. Also add grommets to fabric patches approximately as shown.

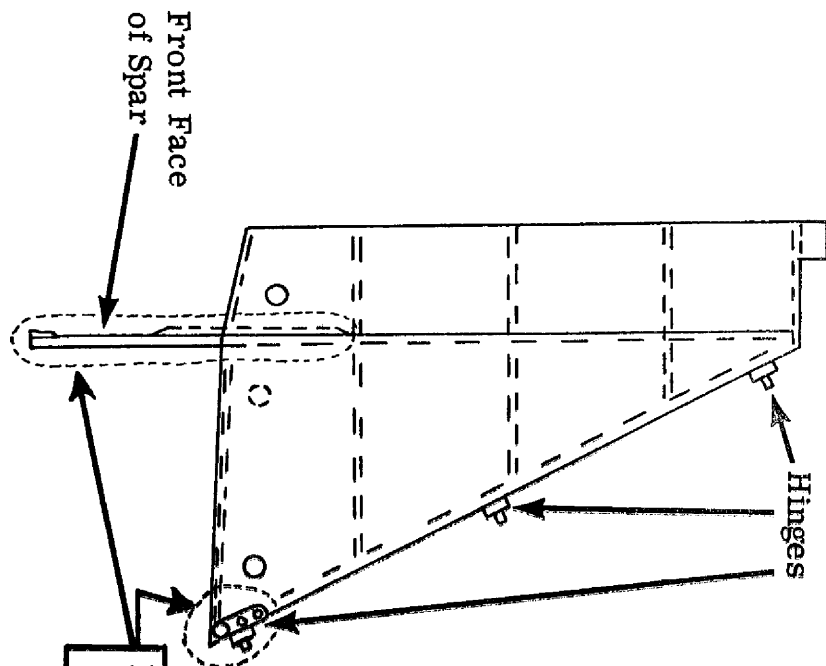
FIG. 3 FIN ASSEMBLY

TOM RIB (reference Figure 3 and 7). The fin main spar below the bottom rib should not be covered with fabric or dope. This will cause a water trap and cause deterioration of wood.

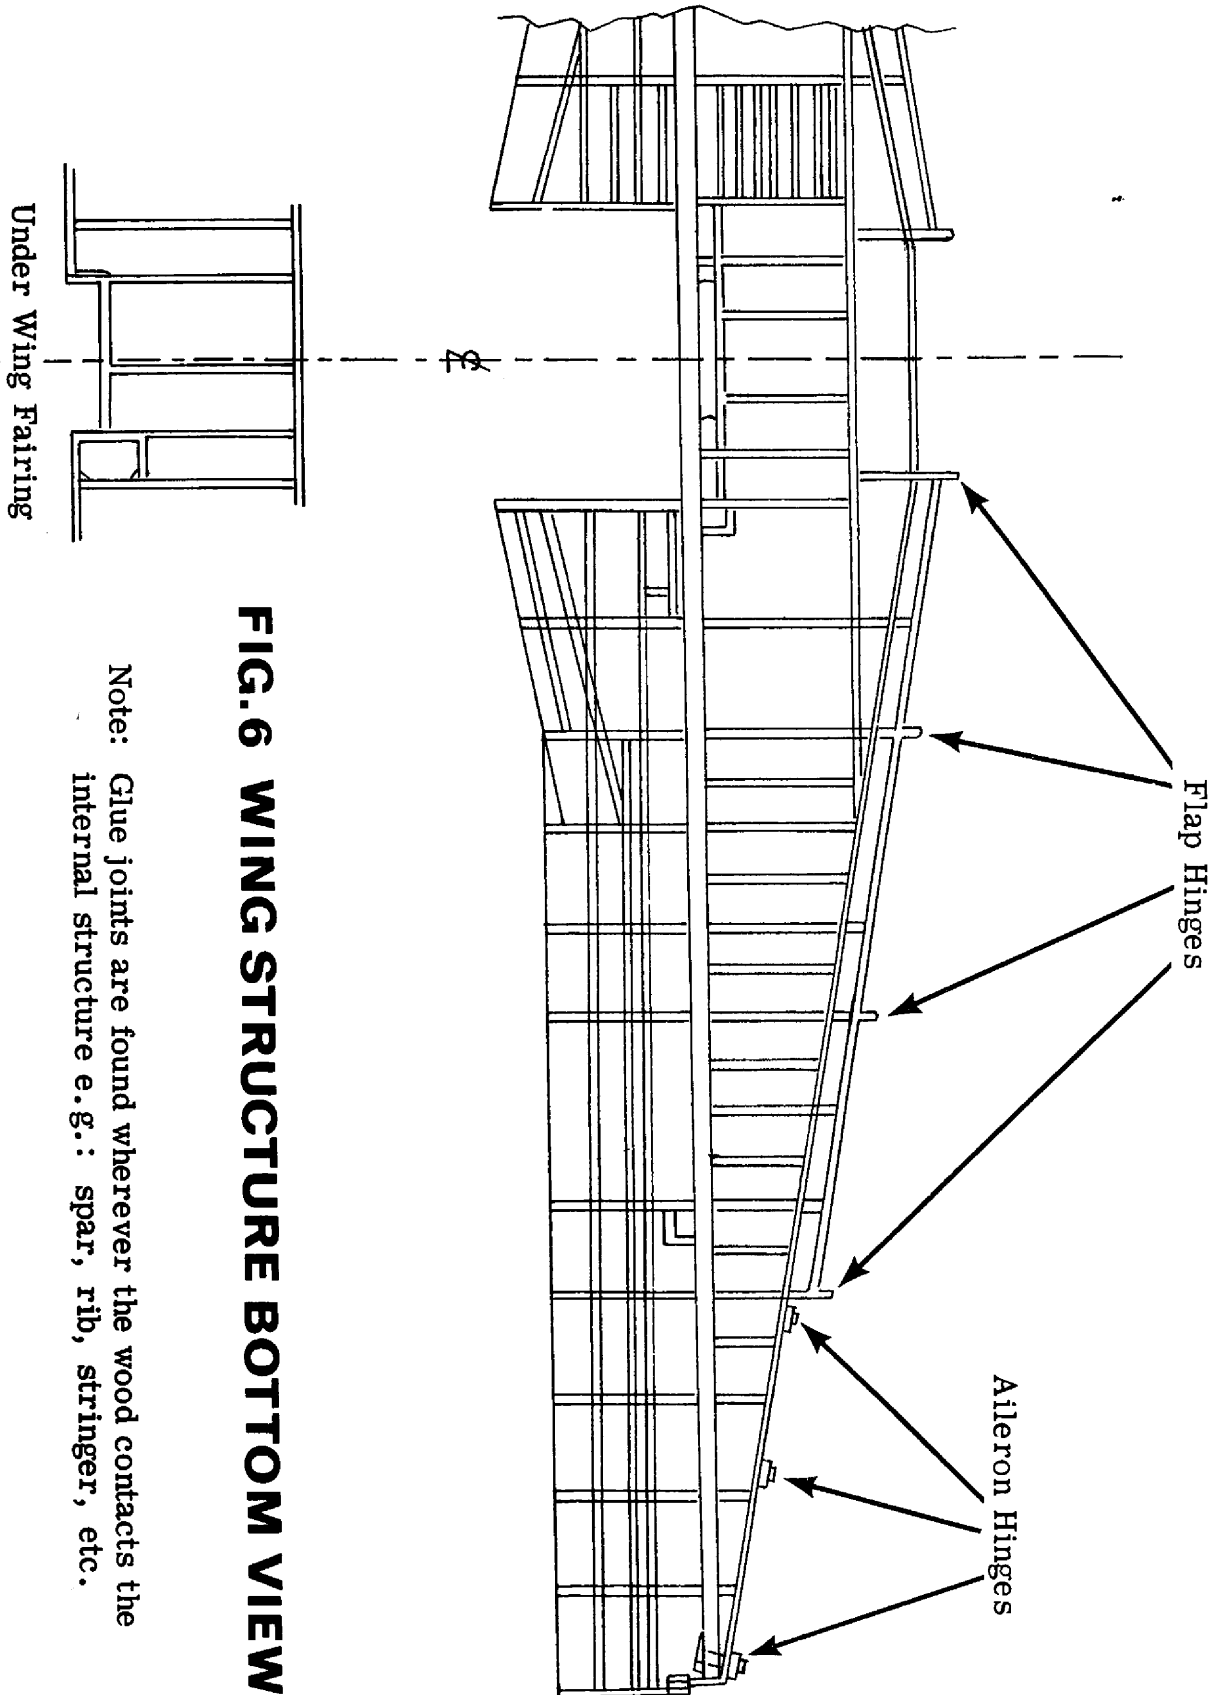
FIG. 6 WING STRUCTURE BOTTOM VIEW

6. Check condition of the wing flap and aileron hinge fitting attach bolts and bushings. (Refer to Figure 6.)
7. Inspect the wood end-grain surrounding bolt holes for evidence of rust, discoloration, deterioration and evidence of moisture accumulation at the trailing edges of the wings.

- mallet or hammer while listening for variations or changes in the sounds emitted. Rework all separated glue joints before further flight (reference Figure 6).

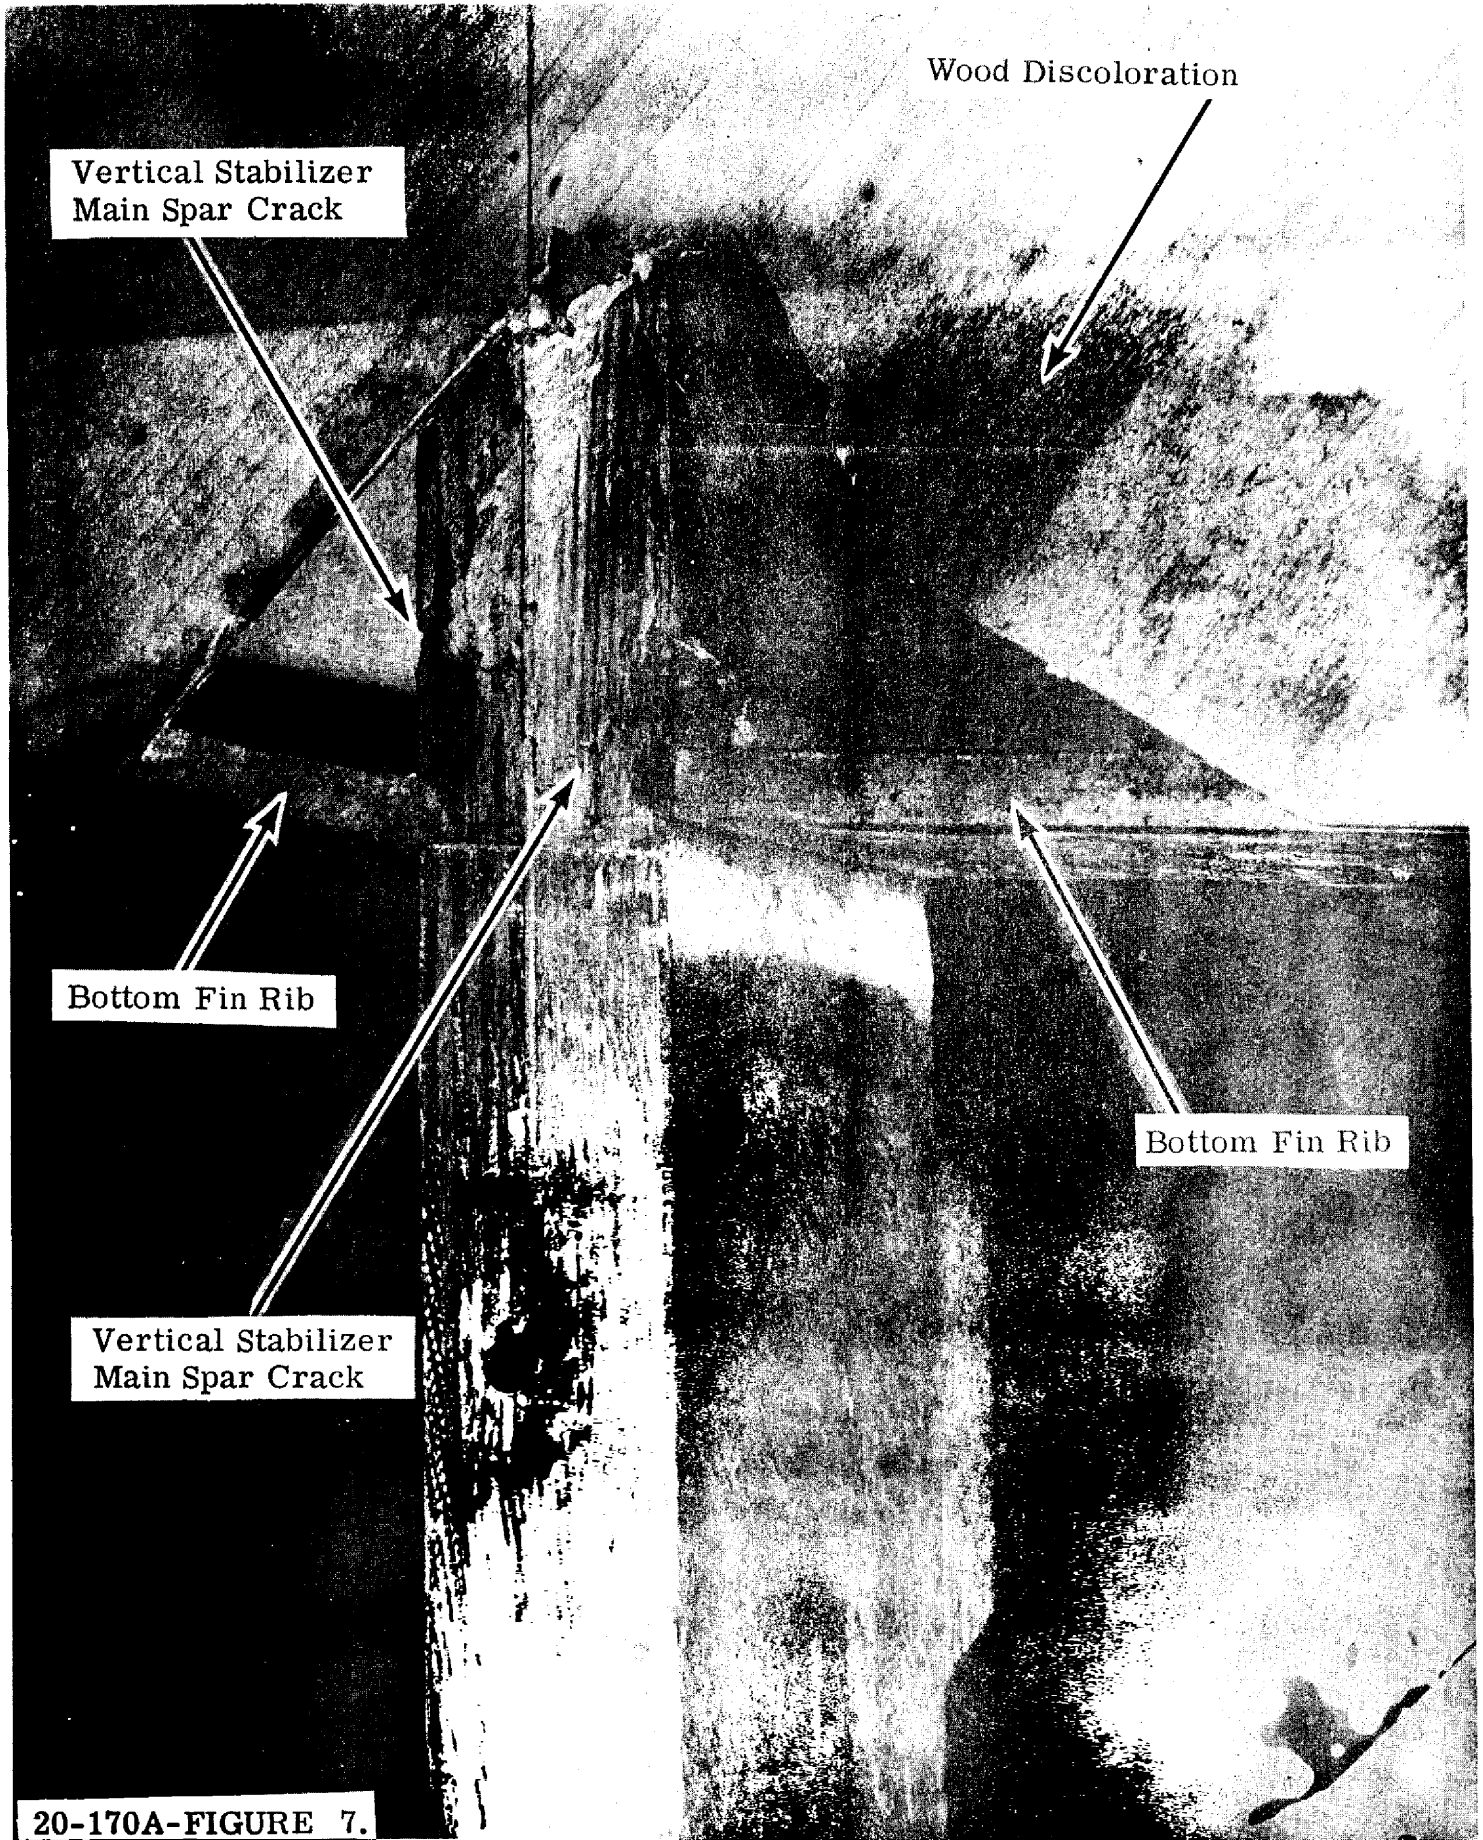
20-170A-FIGURE 7.

Figure 7 is an example of a fin that had flown two weeks before Airworthiness Directive 68-25-6 was released. This fin had passed a visual inspection by an authorized mechanic but failed the detailed inspection of previous Service Bulletin M20-170 Part II D 1, 2. The cracked spar was visible only after removing apparently good fabric and some deteriorated skin. More detailed Inspection Instructions are in-

cluded in this Service Bulletin to prevent oversight during inspection of this area.
