(This Service Bulletin Supersedes Service Bulletin M20-170)

INSTRUCTIONS TO PREVENT VIOLATIONS
OF STANDARD AIRCRAFT PRACTICES FOR
MAINTAINING WOOD STRUCTURES

M20 and M20A, all serial numbers

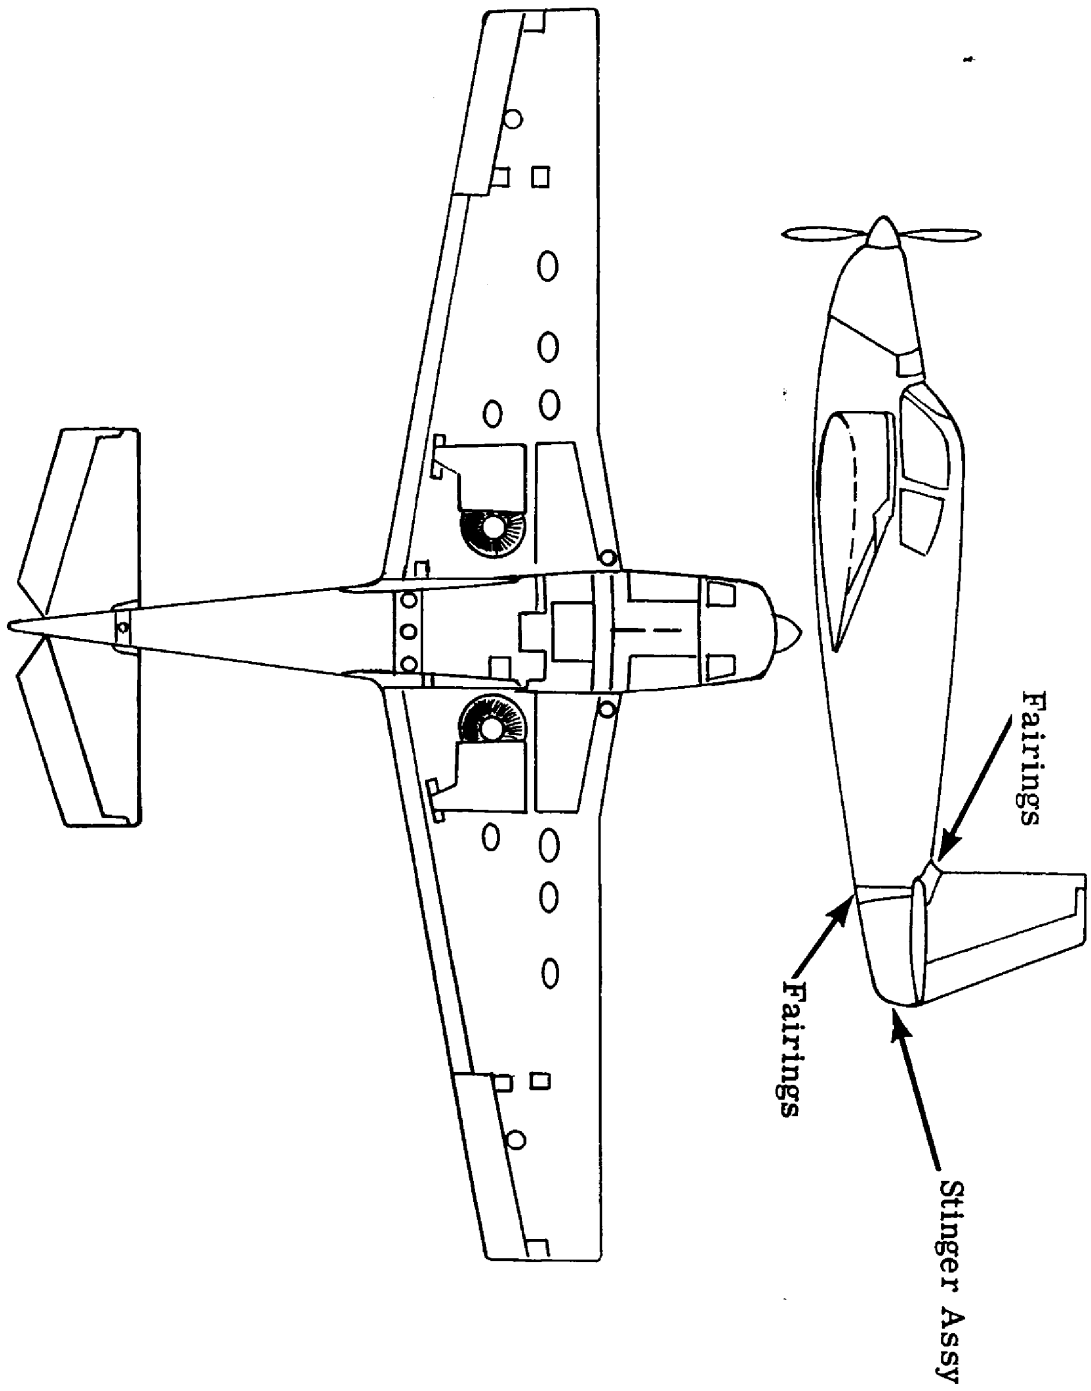
FIG.5 ACCESS DOORS & PANELS

1. Remove the wing to fuselage fairing and fillets.
2. Remove all the wing and center section access doors and panels. (Refer to Figure 5.)
3. Remove the sealing tape at the wing-fuselage joint and inspect the areas around the fittings for evidence of deterioration or joint separation.
